# Safety Screening Report

**Report:** 071-75924520-502 **Date:** 09/01/2014

**Product:** Electrical Socket **ESC Sample Number:** 7

**Summary:** TÜV SÜD Product Service was commissioned by The Electrical Safety Council to evaluate an Electrical Socket (see figure 1). The aim of the assessment is to assess the product against the clients Safety Screening Test Plan.

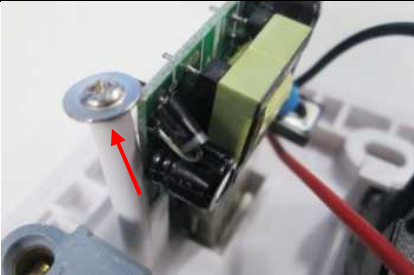
<b>Markings/Photo</b>	<input checked="" type="checkbox"/> -Yes <input type="checkbox"/> -No <i>If yes see last page of report</i>	<b>CE Marking</b>	<input type="checkbox"/> -Yes <input checked="" type="checkbox"/> -No
Construction (BS 1363-2, Clause 13)			
<b>Product Build Quality</b>	<input type="checkbox"/> -Pass <input checked="" type="checkbox"/> -Fail		
<b>Comments</b>	<p>The external construction was of an adequate standard. No sharp edges or burrs were found. The mouldings were considered to be of a lesser standard in comparison to similar products already on the market. The PCB was slotted into the mouldings. This was retained by the outer rims of screws which were inserted into pillars either side. The use of the metal screws in close proximity to the PCB and metal pattress (if used) was not considered appropriate.</p>

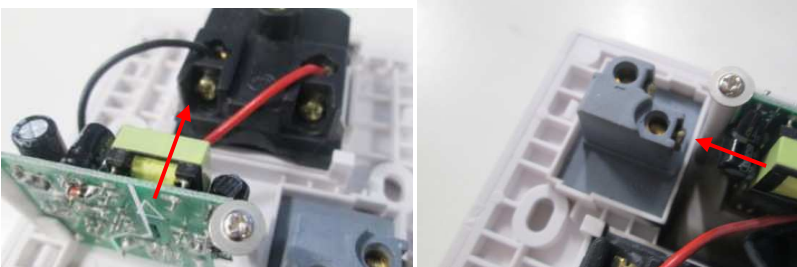
<p>BS 6004 electrical cable was fitted to the sockets conductors in addition to the connections already in place to the PCB. However it was difficult to retain both due to the differing gauges. It was noted the switch to one of the samples had been fitted incorrectly which prevented access to the screw. The PCB required removal to gain access to the conductor socket screw.</p>

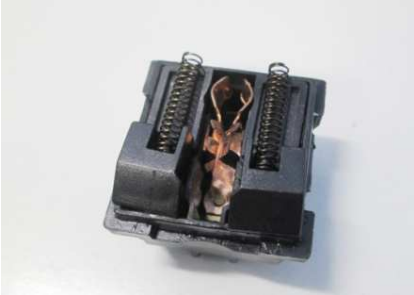
<b>Accessibility of Live Parts (BS 1363-2, Clause 9)</b>	
<b>Constructional Quality</b>	<input type="checkbox"/> -Pass <input checked="" type="checkbox"/> -Fail
<b>Comments</b>	<p>Only the live and neutral sides of the socket were shuttered. Further inspection revealed that these did not operate simultaneously as required by the standard.</p>

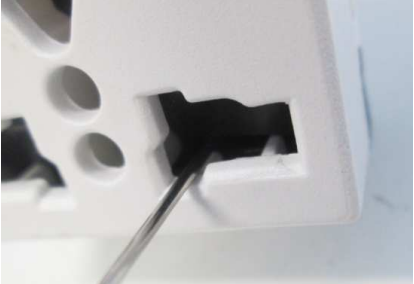
<p>Access to internal live parts was achieved when applying a 1.0mm to the live and neutral output conductors with calibrated test pin. Further inspection revealed that the shutters could not fully close when a plug was extracted due to the form of the internal mouldings.</p>

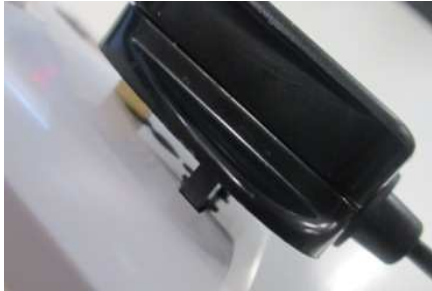
Terminals & Terminations (BS 1363, Clause 11)	
<b>Constructional Quality</b>	<input type="checkbox"/> -Pass <input checked="" type="checkbox"/> -Fail
<b>Comments</b>	<p>A number of BS 1363 approved plugs failed to fully fit into the socket. It was found that the earthing pin required some manipulation to enable it to fully insert. This movement caused some deformation to live and neutral output conductors, potentially causing stress on to the attached input conductors.</p>

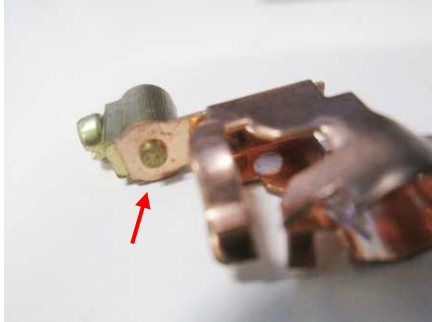
<p>The copper part of the earthing conductor was pressed onto the brass part and not welded as expected. This assembly was also noted to be loose within the moulding.</p>

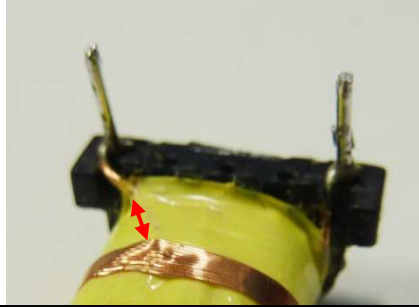
<b>Creepage Distances, Clearances &amp; Distances Through Insulation (BS EN 61558-1, Clause 26)</b>	
<b>Constructional Quality</b>	<input type="checkbox"/> -Pass <input checked="" type="checkbox"/> -Fail
<b>Comments</b>	<p>The minimum creepage / clearance distance measured between the primary and secondary side of the circuit board (2.5mm) with a 1.3mm slot was found to be within the limit of the standard. There was a minimum distance measured between the primary and secondary transformer windings (3.7mm) therefore did not meet the requirement of the standard. A minimum of 5mm is required.</p>

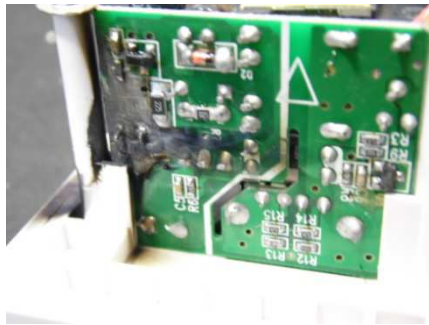
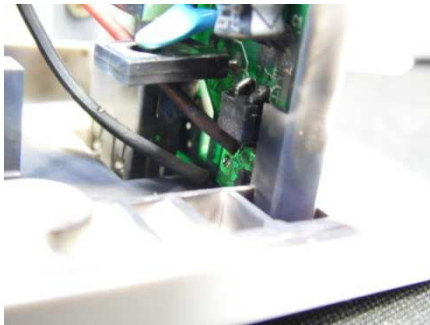
The device was setup with a load bank and the load slowly increased to 0.5A. The temperature was monitored around the device. After about 1.5 hours the sample exploded and the test was stopped. Both USB socket wires were blown off the PCB and it appeared an 8.2Ω surface mount resistor exploded.

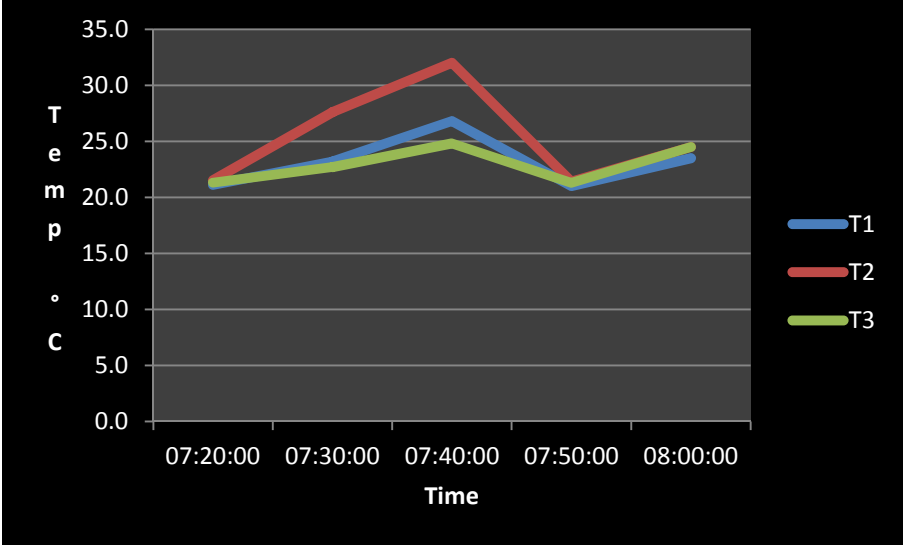
Time	T1 (°C)	T2 (°C)	T3 (°C)
07:20:00	21.0	21.0	21.0
07:30:00	23.0	27.0	23.0
07:40:00	27.0	32.0	25.0
07:50:00	21.0	21.0	21.0
08:00:00	23.0	23.0	23.0

T1=Left of USB socket  
T2=Right of USB socket  
T3=Base

The maximum recorded temperature was 32.0°C.

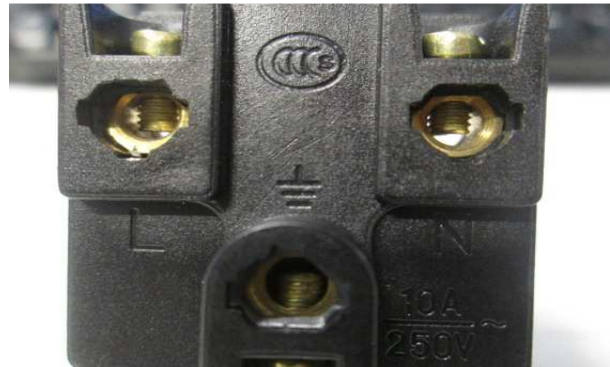
**Markings**

Findings			
Markings/Warnings (BS 1363-2, Clause 7)			
<b>Marking of Product</b>	<input checked="" type="checkbox"/> -Inadequate <input type="checkbox"/> -Poor <input type="checkbox"/> -Adequate <input type="checkbox"/> -Good <input type="checkbox"/> -Very Good <input type="checkbox"/> -N/A		
<b>Comments</b>	<p>The product as a unit was unmarked. A model reference, distributor name / trademark, WEEE log and CE marking were missing and must be present.</p> <p>The socket assembly was marked with electrical ratings and the CCC mark which could not be verified online. BS 1363 was not present; therefore not considered to be UK approved. The conductor inputs were clearly marked.</p> <p>The switch was also marked with the CCC mark. The switch current rating stated was 10A for a 13A socket. A part reference / manufacturer trademark was missing. The USB output ratings were missing and should be made available / visible to the end user.</p> <p>There were no instructions supplied with the product to enable an assessment. Information covering general safety, installation and operation should be made available to the installer / end user. The packaging stated that the product was suitable for digital products including mobile phones, cameras and MP3s.</p>
