TEST REPORT

No: 43478-1

Item/s tested 600mm LED linear retro fit lamps for fluorescent
luminaires
See the following pages of this report for details

Tested to Investigation looking at the effect of using LED linear
lamps as direct replacements for standard fluorescent
lamps against reference standards EN60968 : 2000
and EN60598-1 : 2008

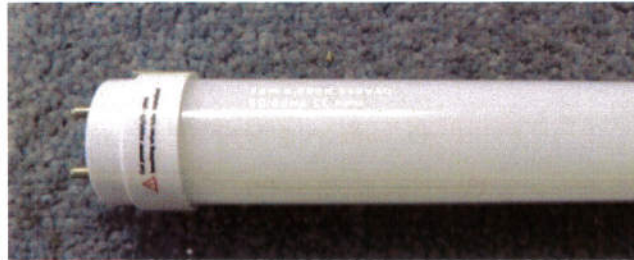
Photograph of identification

Lamp details: 12W 6000K G13, 230VAC 50/60Hz

Marking Details: The lamp is marked with the following:

12W 6000K G13, 230VAC 50/60Hz

The is a circuit diagram etched on to the lamp

The lamp caps are marked with a warning stating cut power supply / no pins touching when tube installed.

The above LED retro fit lamp was declared as a direct replacement for a fluorescent lamp. The LED retro fit lamp was placed between a pair of lampholders mounted within a single fluorescent wire wound control gear batten luminaire. As per the instructions supplied with the LED retro fit lamp the only item removed from the wire wound control gear was the starter switch. When the supply was connected to the luminaire, the LED retro fit lamp operated instantly.

It was possible to re-use the fitting with a fluorescent tube after modification. There would be no potential hazard relating to a fluorescent lamp being used in place of the LED retro fit lamp in a luminaire with wire wound gear fitted as only the starter switch would need to be replaced for the fitting to work as originally intended.

Direct Retro Fit : YES (with Starter Switch removed from the fluorescent control gear circuit)

Maximum voltage measured during removal of lamp between live pins of the lamp & earth = 1.9V

Maximum Current measured 10mA

This combination of voltage and current is not considered a Hazard
(ref:- IEC 61140: 2001 +A1: 2004 clause 5.1.6)

Direct Retro Fit: No (electronic or high frequency ballasts need to be removed or bypassed before fitting the LED lamp).

When a high frequency/ electronic fluorescent luminaire is modified in this way it will no longer accept its original lamp therefore there is a potential hazard relating to a fluorescent lamp being used in place of the LED lamp.

Maximum voltage measured during removal of lamp between live pins of the lamp & earth : 2.5V
Current measured 10mA

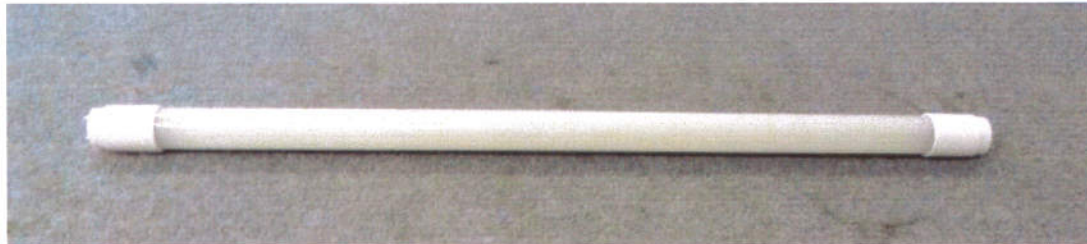
Lamp No : 3
Photograph of identification

Lamp Details : 9W T8 G13, 240VAC 50/60Hz (Information obtained from the internet)

Marking Details : There were no markings on the lamp

There is no declaration given stating that the T8 LED tube is a direct replacement for fluorescent tubes.

As the luminaire has been modified it will no longer accept its original lamp therefore there is a potential hazard relating to a fluorescent lamp being used in place of the LED retro fit lamp.

When a fluorescent lamp is fitted without the appropriate control gear the lamp cathodes within the tube are blown apart as mains voltage is applied directly across the lamp.

Maximum voltage measured during removal of lamp between live pins of the lamp & earth: 90VAC

Current measured : between the lamp pins and the earth was 10.0mA

This combination of voltage and current may be considered a Hazard in certain circumstances (ref:- IEC 61140: 2001 +A1: 2004 clause 5.1.6)
