Safety Screening Report

Report: 071-75924520-801 **Date:** 18/12/2013

Product: Electrical Socket **ESC Sample Number:** 6

Summary: TÜV SÜD Product Service was commissioned by The Electrical Safety Council to evaluate an Electrical Socket (see figure 1). The aim of the assessment is to assess the product against the clients Safety Screening Test Plan.

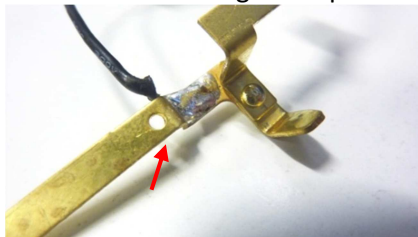
Appropriately sized / threaded screws were used.
Internal Wiring / Separation (BS EN 61558-1, Clause 21)	
Constructional Quality	<input checked="" type="checkbox"/> -Pass <input type="checkbox"/> -Fail
Comments	The output (SELV) circuit was found to be adequately separated from the input circuit. The live parts of the SELV circuit were not in direct contact with the protective earth. There internal wiring was UL marked. This was verified online.
Screws, Current Carrying Parts & Connections (BS 1363-2, Clause 13)	
Constructional Quality	<input checked="" type="checkbox"/> -Pass <input type="checkbox"/> -Fail
Comments	<p>The switches, internal conductors and USB sockets were adequately retained by the structure of the mouldings which was then secured by screws and a riveted earthing brace. The connections to the PCB were mechanically secured / soldered in; however the connection to the neutral conductor had been soldered where means to secure it had not been utilised. It is recommended that a form of mechanical security is used in addition to soldering when provided.</p>

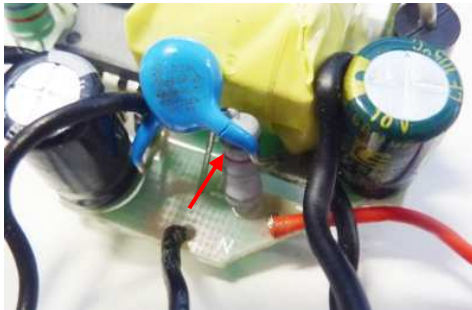
damage was observed.
Insulation Resistance / Leakage Current (BS EN 61558-1, Clause 18.2)	
Result	<input checked="" type="checkbox"/> -Pass <input type="checkbox"/> -Fail
Comments	The product was subjected to an insulation resistance test with a voltage of 500VDC applied. This was measured between live / neutral and the USB output. A measurement of >999MΩ was recorded across each path; therefore meeting the requirement of >5MΩ.
Electric Strength (BS 1363-2, Clause 15 / BS EN 61558-1, Clause 18)	
Result	<input type="checkbox"/> -Pass <input checked="" type="checkbox"/> -Fail
Comments	<p>The product was subjected to an electric strength test to 1500VAC no breakdown or flashover occurred. The mains output was tested to 4242VDC; however breakdown occurred at 800VDC. A burn test revealed arcing between the fusible resistor and the tail of X1 capacitor which were in direct contact with each other.</p>

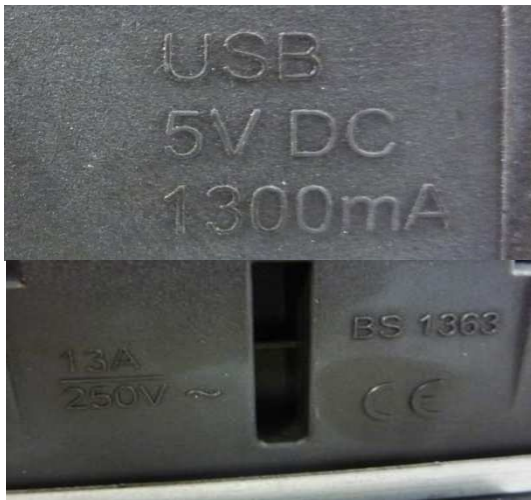
Markings

Findings			
Markings/Warnings (BS 1363-2, Clause 7)			
Marking of Product	<input type="checkbox"/> -Inadequate <input type="checkbox"/> -Poor <input checked="" type="checkbox"/> -Adequate <input type="checkbox"/> -Good <input type="checkbox"/> -Very Good <input type="checkbox"/> -N/A		
Comments	<p>The product was adequately marked with the distributors name, model reference, electrical ratings (covering both the socket and USB's) and CE marking. The USB ratings were noted to be clearly visible to the end user; however the WEEE logo was missing. This should be added.</p> <p>A generic instruction leaflet was supplied with the product. This was found to contain a good amount of installation, operational and safety information; however there was no compatibility advice. It is recommended that this is included.</p>		
Markings/Photo	<input checked="" type="checkbox"/> -Yes <input type="checkbox"/> -No <i>If yes see last page of report</i>	CE Marking	<input checked="" type="checkbox"/> -Yes <input type="checkbox"/> -No
