Screening Report

Report: 071-75924520-101 **Date:** 18/12/2013

Product: Electrical Accessory **ESC Sample Number:** 8

Testing Information	
Testing Laboratory:	TÜV SÜD Product Service
Location:	Octagon House, Concorde Way, Segensworth North, Fareham, Hampshire, PO15 5RL. UK.
Client:	The Electrical Safety Council
ESC Sample Number:	8
Product Information	
Product Description:	Trailing socket with Integrated USB Ports
Rated Input Voltage:	250VAC
Rated Output:	USB – 2 x 5VDC / 500mA
Protection Class:	Class I

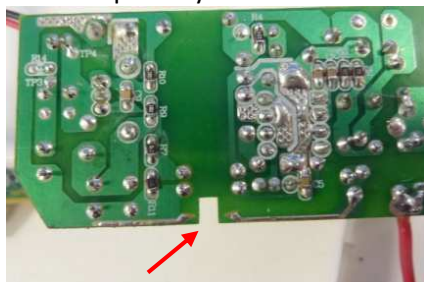
Creepage Distances, Clearances & Distances Through Insulation (BS EN 61558-1, Clause 26)	
Constructional Quality	<input type="checkbox"/> -Pass <input checked="" type="checkbox"/> -Fail
Comments	<p>The minimum clearance distance measured between the primary and secondary sides of the circuit board (4.4mm) was close to the limit required by the standard (>5mm). The transformer was adequately constructed with a triple insulated secondary winding, providing an adequate barrier from the primary side.</p>

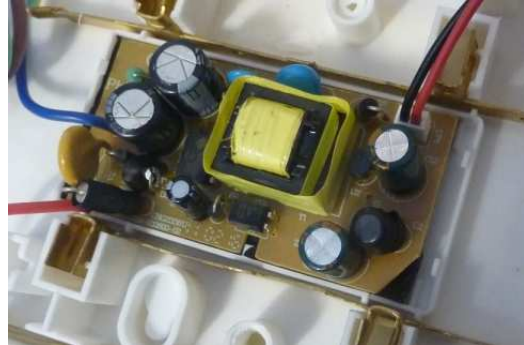
Control PCB

Constructional Quality	<input checked="" type="checkbox"/> -Pass <input type="checkbox"/> -Fail
Comments	<p>The connections to the both the control and surge circuits had been mechanically secured / soldered. The input connections to the conductor strip was found to be suitably retained by crimping; however this method had not been employed to any of the other conductor connections, these were soldered only. It is recommended that two forms of security are used.</p>

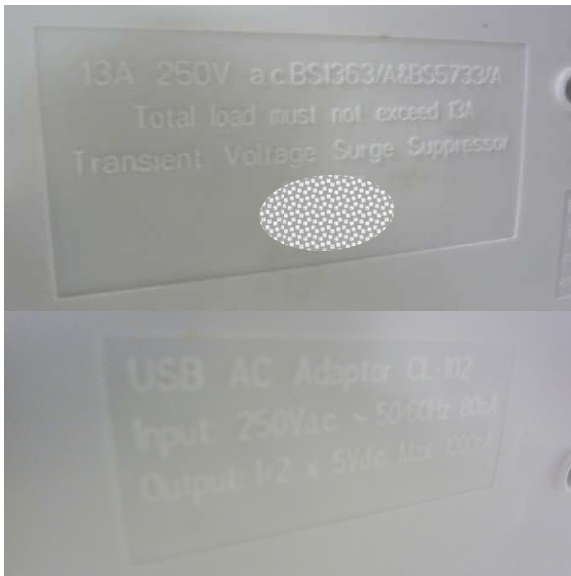
Markings

Findings	
Markings/Warnings BS 5733, Clause	
Marking of Product	<input checked="" type="checkbox"/> -Inadequate <input type="checkbox"/> -Poor <input type="checkbox"/> -Adequate <input type="checkbox"/> -Good <input type="checkbox"/> -Very Good <input type="checkbox"/> -N/A
Comments	<p>The product was marked with the model reference, electrical ratings (low voltage / SELV) and applicable standards (BS 1363 / BS 5733). A known manufacture's trademark was present; however there was no information relating to the distributor (on packaging only) and this must be added. The WEEE logo and CE marking were also missing. There was no standard stated to suggest conformity of the USB outputs.</p> <p>There were some brief instructional / safety information provided on the packaging's carded insert which state that the product is suitable for charging items such as MP3 players, mobile phones, and digital cameras; however this was non-specific. The safety information covered the extension as a whole (including surge protection). There were no compatibility warnings directly related to the USB interface.</p>

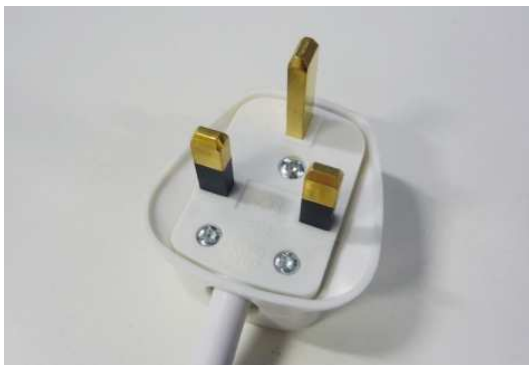
Plug

Terminals & Terminations (BS 5733, Clause 14)	
Constructional Quality	<input checked="" type="checkbox"/> -Pass <input type="checkbox"/> -Fail
Comments	<p>The product was fitted with an approved 13A, BS 1363 plug and a BS 6500 marked (superseded by BS EN 50525) 3*1.25mm supply cord, both parts were registered to a known manufacturer. It was noted that the cord measured at 1.87M, not 2.0M as stated on the packaging.</p> <p>A quick check revealed that some resistance was felt when an approved BS 1363 plug was inserted into the socket.</p>
Internal Wiring / Separation (BS EN 61558-1, Clause 21)	
Constructional Quality	<input checked="" type="checkbox"/> -Pass <input type="checkbox"/> -Fail
Comments	The output (SELV) circuit was found to be adequately separated from the input circuit. The Live parts of the SELV circuit were not in contact or exposed to the earth.
Screws, Current Carrying Parts & Connections (BS 5733, Clause 14 & 15)

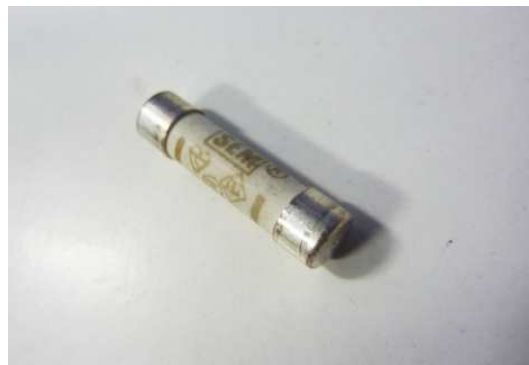
Fuse

Short Circuit, Overload and Thermal Protection (BS EN 61558-1, Clause 15)	
Constructional Quality	<input checked="" type="checkbox"/> -Pass <input type="checkbox"/> -Fail
Comments	A cartridge fuse was fitted to the primary side of the control circuit. A thermal protection device was also found on the surge protection circuit. The VDE marking seen was verified online.
Mechanical Strength (BS 5733, Clause 21)	
Result	<input checked="" type="checkbox"/> -Pass <input type="checkbox"/> -Fail
Comments	<p>The product was subjected to an impact test. This was carried out with the free end of the cable held against a wall with the cable held horizontally at 400mm above a hard floor then allowed to drop. This was repeated with the cord rotated through 45° at its fixing eight times. No damage was observed.</p> <p>Standard USB connectors were placed into each socket then subjected to an impact test of 5Nm to all sides. Some deformation of the sockets metal casing was noted; however this did not affect the mechanical fit of a USB plug.</p>
